## DAM INSPECTION CHECKLIST POSSUM POINT POWER STATION POND ABC

INSPECTION DATE: 6/3/15				
WEATHER: 59°F, Overcast				
INSPECTED BY: D. West, K. Homza

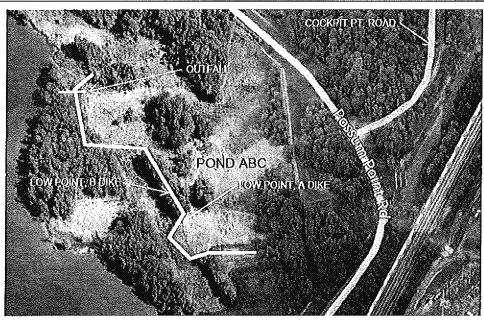
\* See figure below.

Location/ Condition	(y/n)	Change (y/n)	Comments
Low Point, A dike*			
Flow	N	N	0943 hrs. Standing vale in road ruts and
Erosion	N	N	along perimeter of pend new road. No Standing water
Low Point, B dike*			
Flow	N	N	0946 hrs. No standing water. Sand buys and
Erosion	N	N	rip rap in place.
Outfall		E Commence	
water surface El.			0950 hrs. Standing water behind sundbays and corner conrects weir. Slight drip at weir near to NW corner 56".
(top of stoplogs to water)			564.

Additional Comments (Note any changes observed along the embankment crest or downstream slope observed from the crest.): Rainfall event of 1.33" ending 6/2/15 around 1400 hrs. Standing water at the base of the slope between A + B.
